Reducing shutdowns

by ICR Research

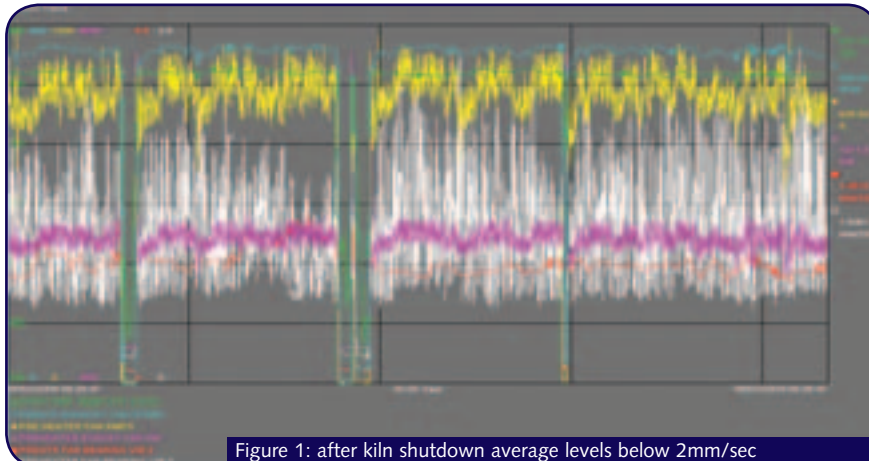
Figure 1: after kiln shutdown average levels below 2mm/sec

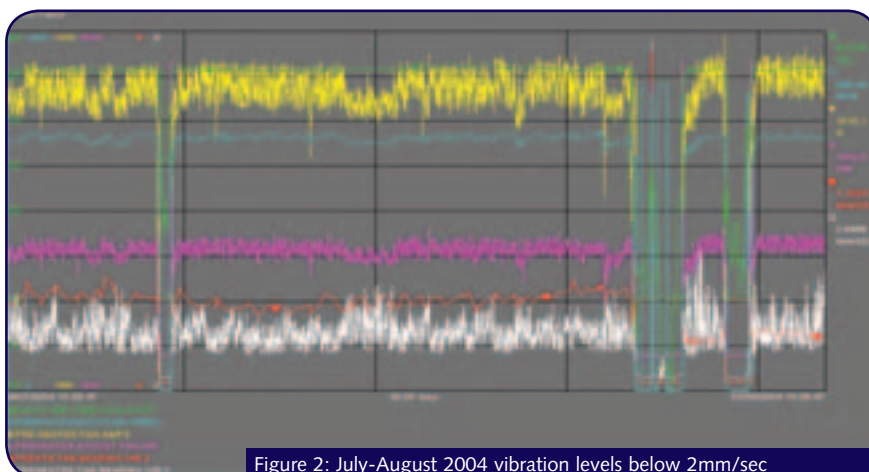
Figure 2: July-August 2004 vibration levels below 2mm/sec

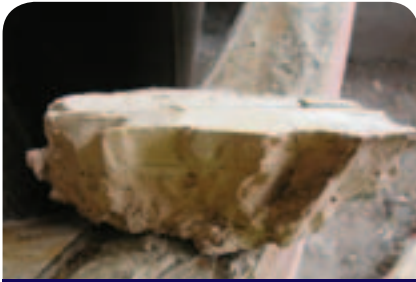
Figure 4: unscheduled forced shutdowns to clean fan. Four kiln stops in 2005

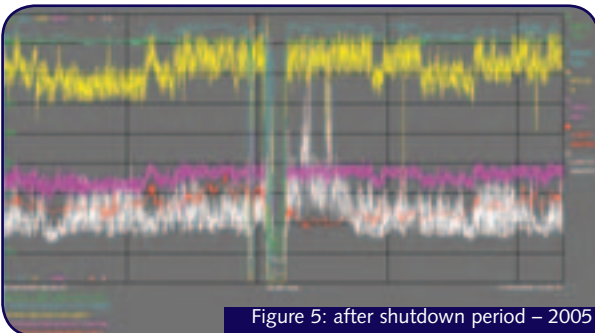
Figure 5: after shutdown period – 2005

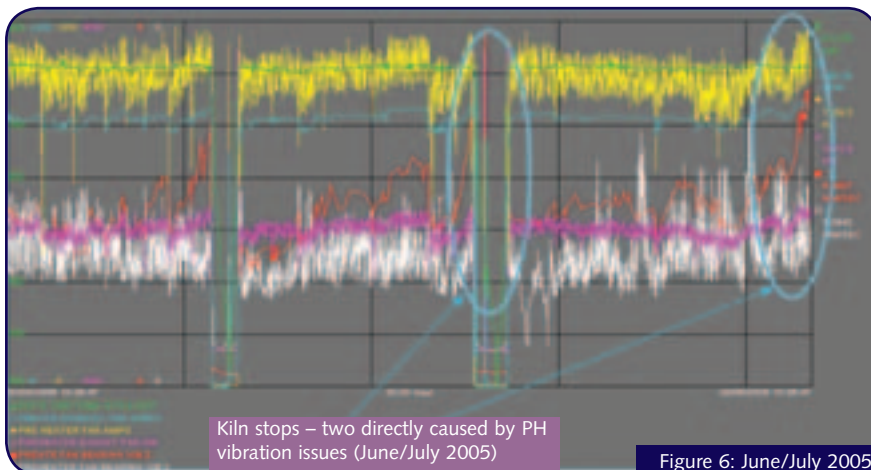
Figure 6: June/July 2005

Kiln stops – two directly caused by PH vibration issues (June/July 2005)

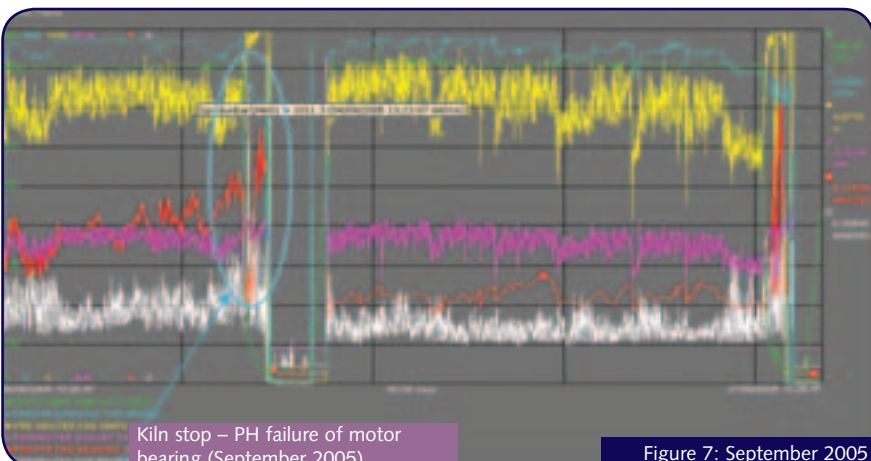
Figure 7: September 2005

Kiln stop – PH failure of motor bearing (September 2005)

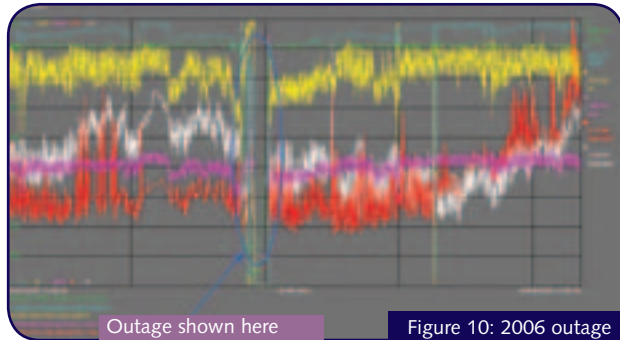
Figure 10: 2006 outage

Because of the integration of LORD Corporation's balancing system, shutdowns from excessive vibration are a thing of the past (see Figures 10-12). As of September, Lafarge had identified at least six scenarios when the balancing system was able to make a correction and avoid an unscheduled shutdown. The balancing system not only allows the fan to run at extremely low vibration levels but it also keeps the plant from having to deal with unscheduled stops (see Table 1). For Lafarge, what is equally as important as the reduction of downtime is that it could continue to increase output.
